Manhole Inspection Summary

Manhole # S35QQ_009MH

Insp Date: **1/19/07 2:36 PM**

Location Address: **2506 25 1/2 ST**

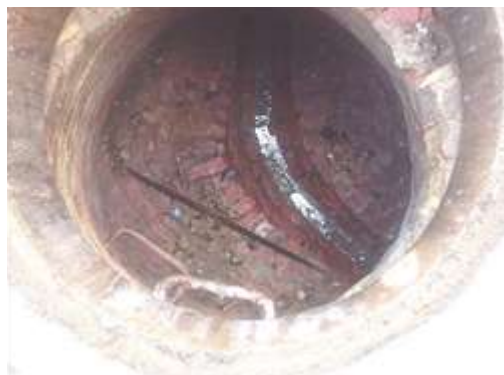
Top View

Corroded steps. Bench debris.

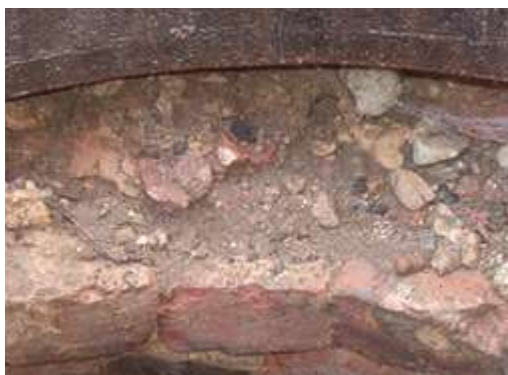
Defect

Frame leaks. Frame offset. Adjustment deterioration and infiltration.

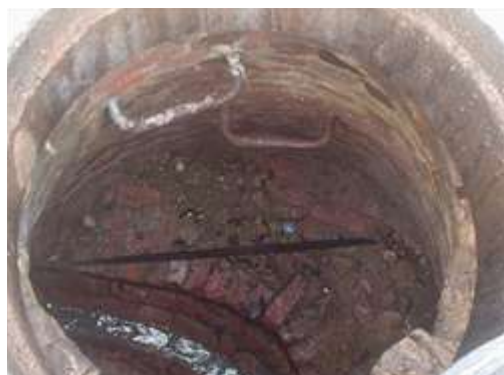
Defect

Frame leaks. Frame offset. Adjustment deterioration, loose brick and infiltration. Barrel infiltration.

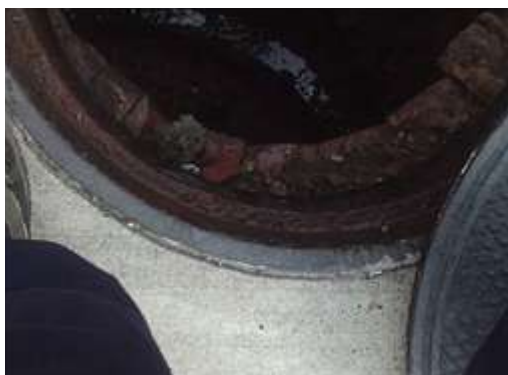
Defect

Frame leaks. Frame offset. Adjustment deterioration, loose brick and infiltration.

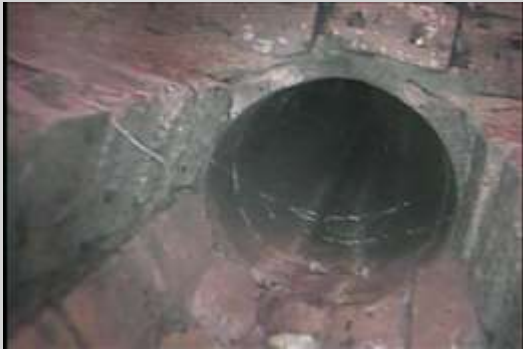
8 in. Circular Gravity Sewer Pipe Out @ 12 O'Clock

Channel deterioration.

Infiltration: **Evidence** Pipe Seal Cond: **Unknown**
